# VP1373 Max Photos

| Project Number | VP1373 |
| Photographer | L. Goodnight |

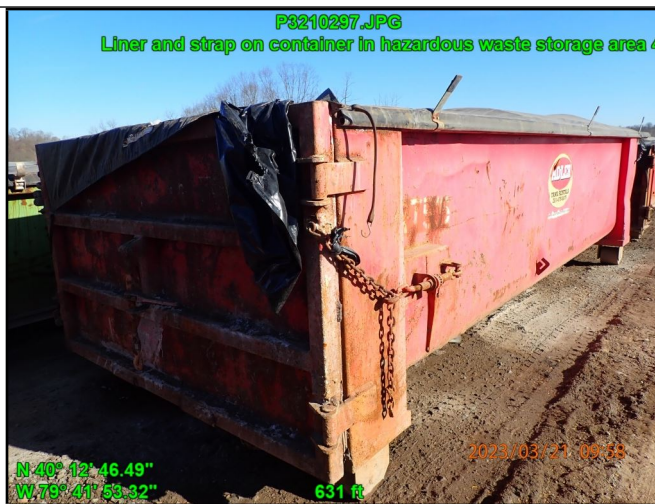
| Description | Liner and strap on container in hazardous waste storage area 4 |

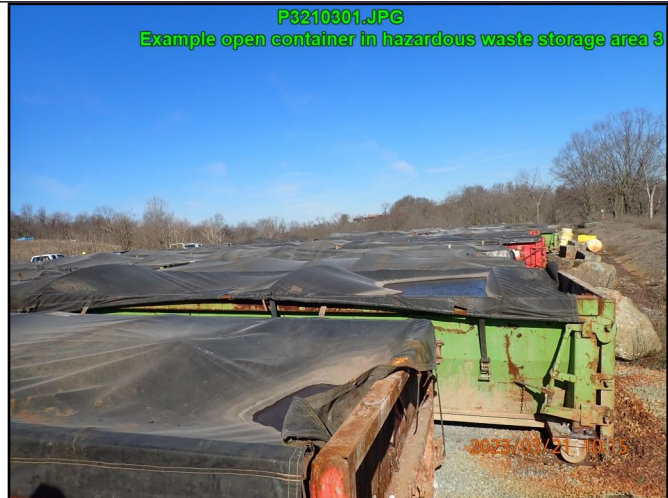
| Description | Example open container in hazardous waste storage area 3 |

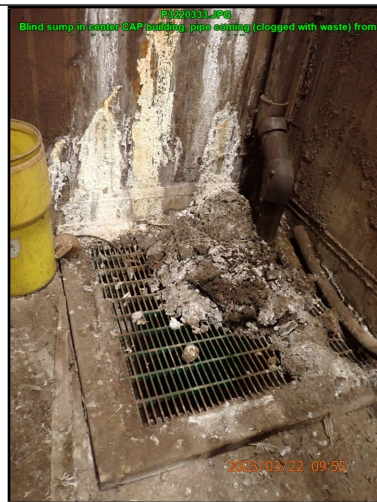
| Attributes | |
|---|---|
| Description | Blind sump in center CAP building, pipe coming (clogged with waste) from bay 2. Vertical pipe from former CAF process, currently no flow |

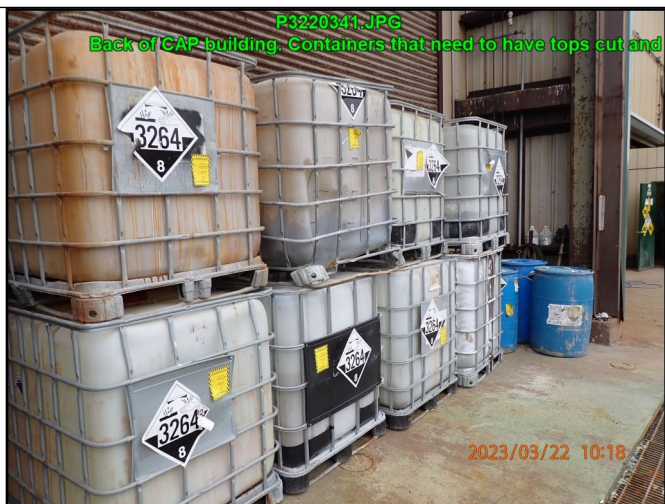
| Description | Back of CAP building. Containers that need to have tops cut and material removed for treatment and trench that feed exterior CAP sump by bay 4 |

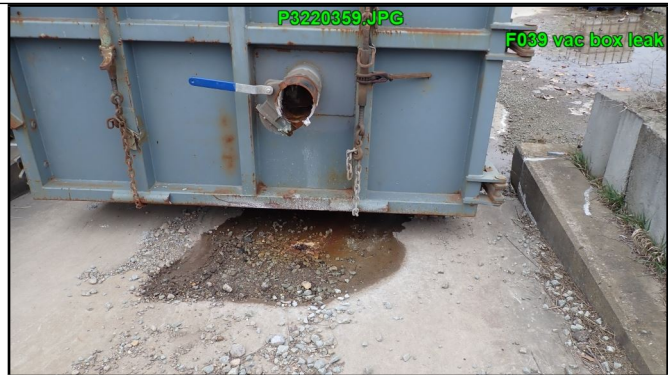
| Description | F039 vac box leak |

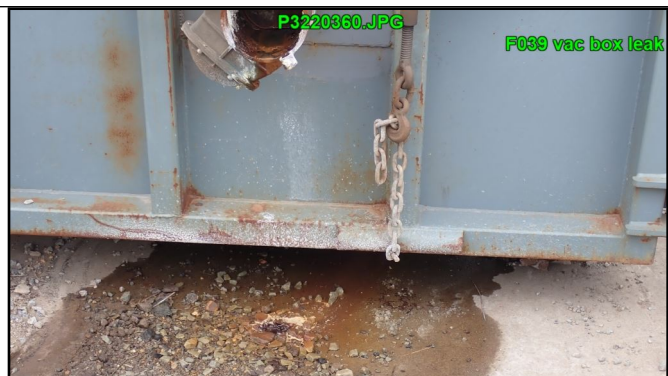
| Description | F039 vac box leak |

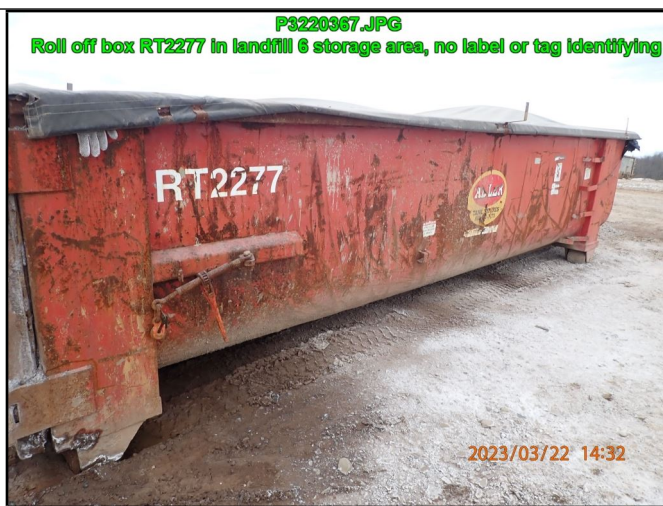
| Description | Roll off box RT2277 in landfill 6 storage area, no label or tag identifying the waste |

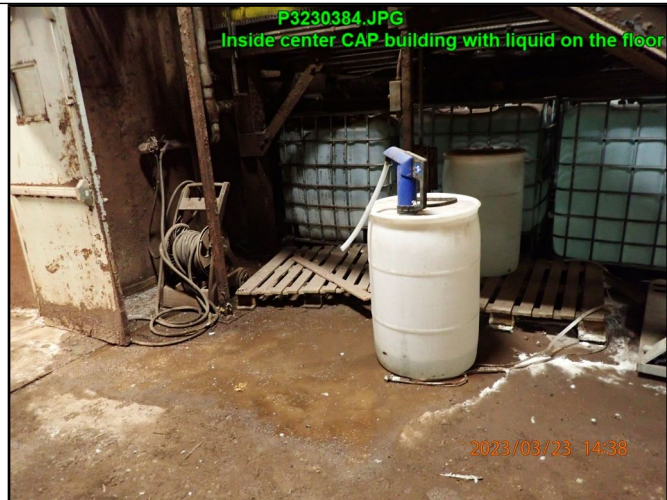
| Description | Inside center CAP building with liquid on the floor |
