RE: MAX Environmental Response to NEIC July 21, 2023 inspection report regarding
March 2023 NEIC and EPA inspection of the MAX Yukon facility

NEIC inspection report

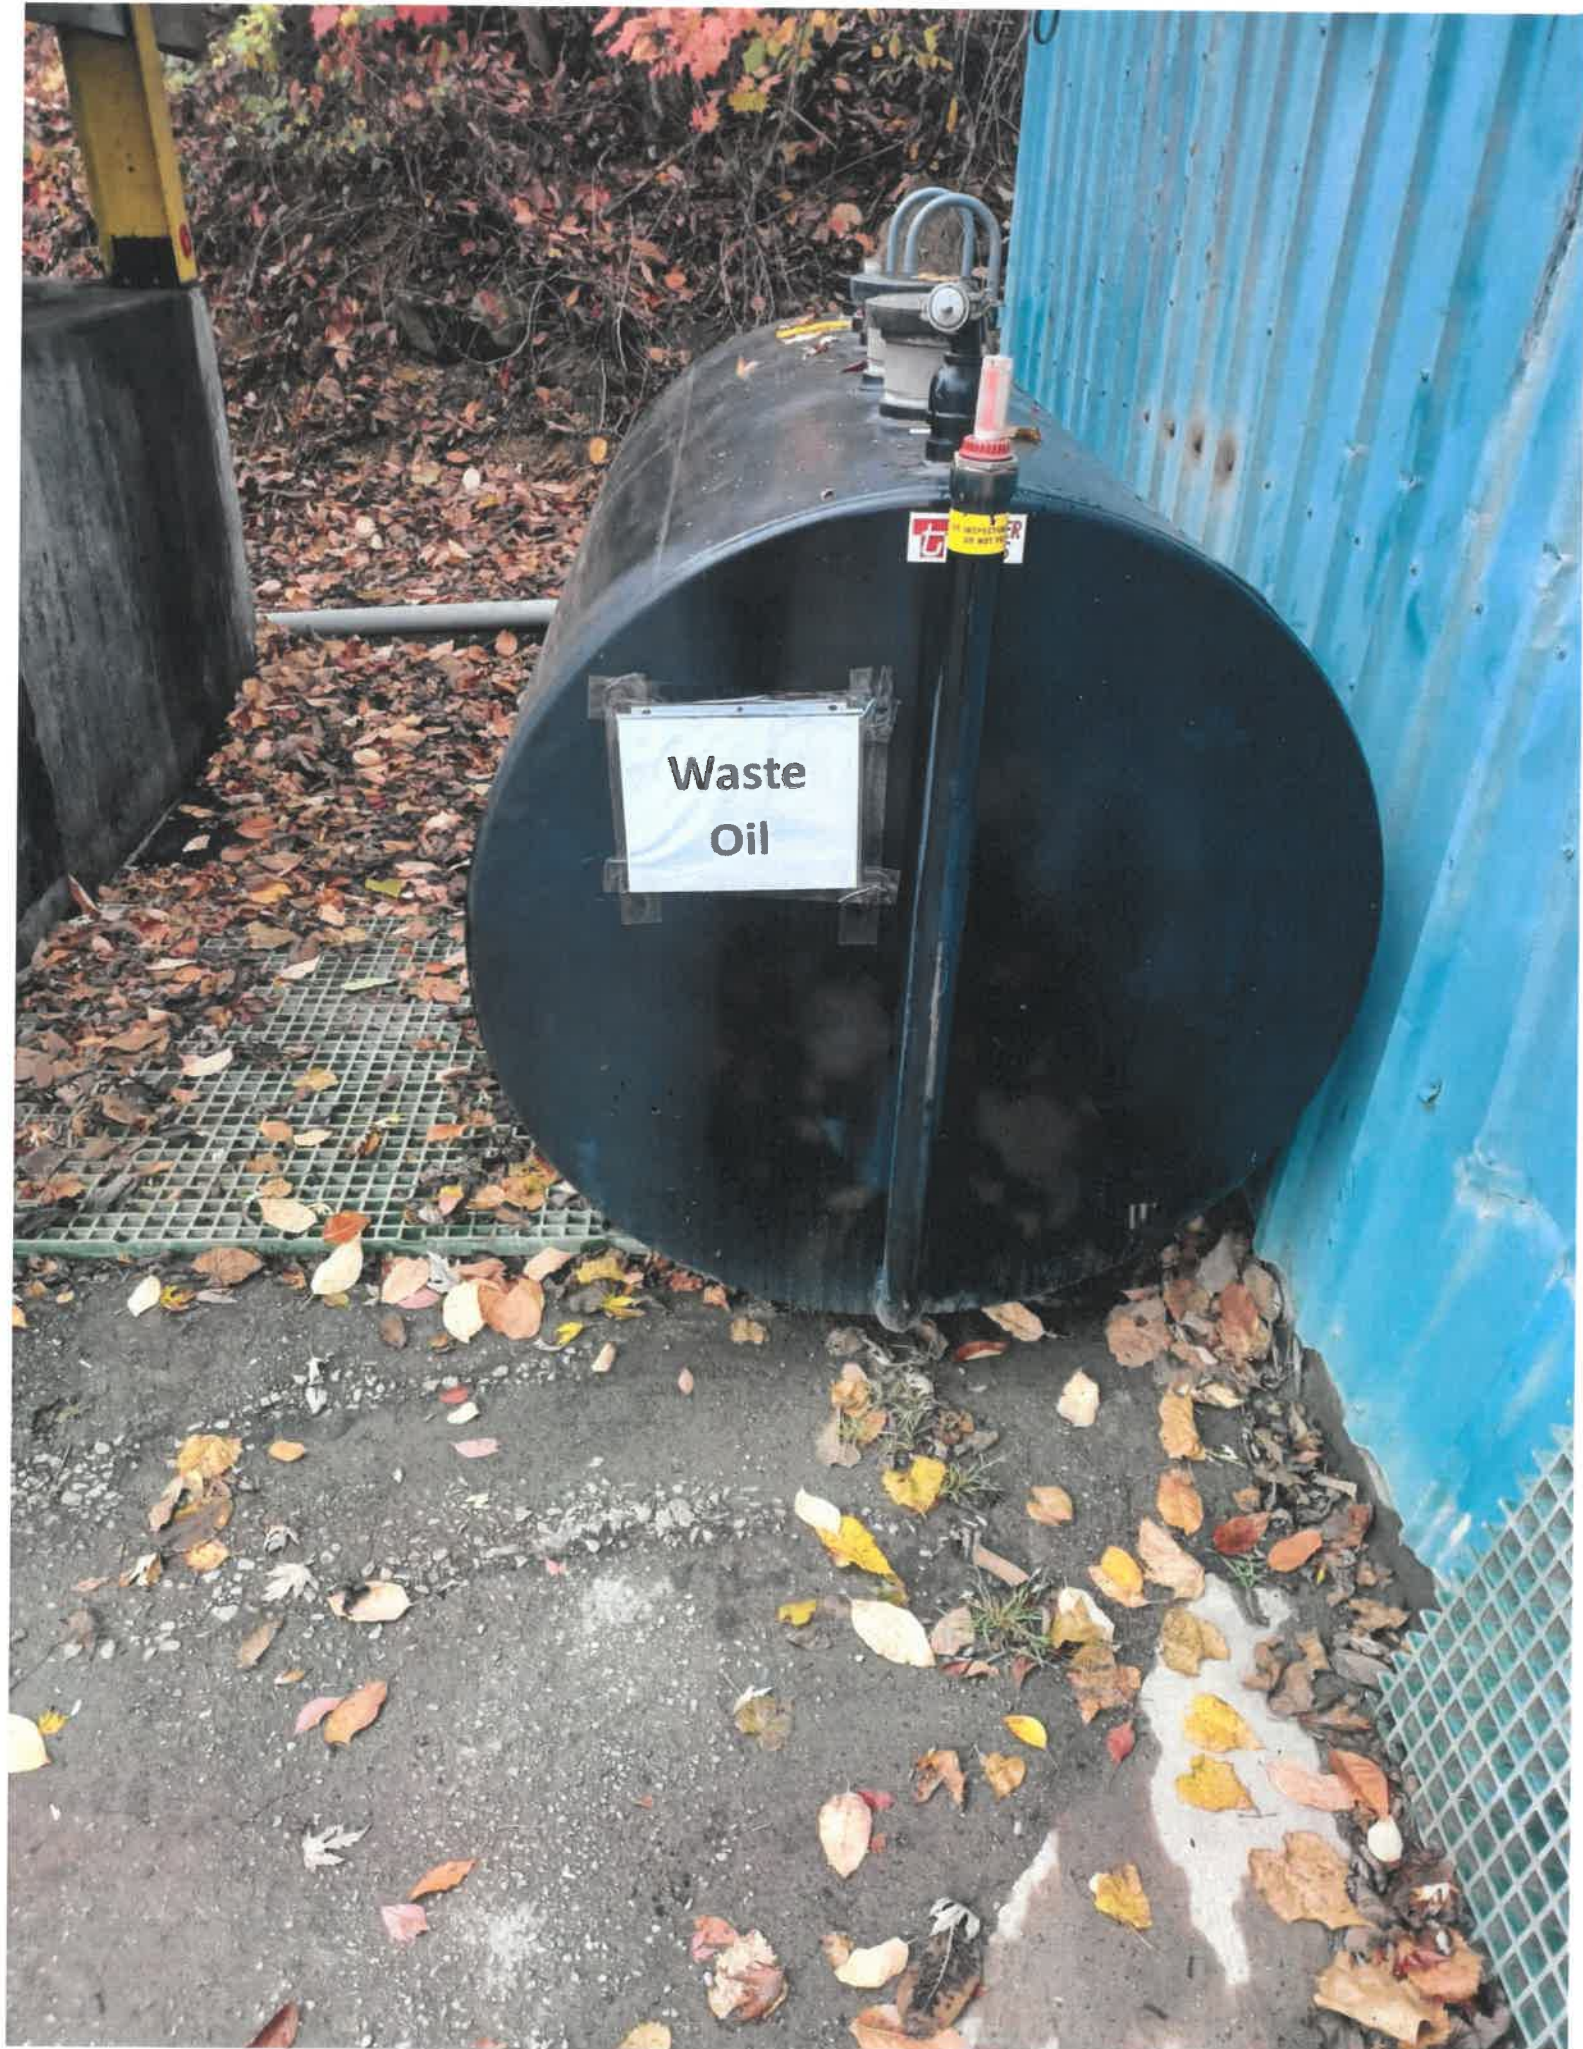
NEIC indicated that a small tank used for the accumulation of waste oil may be leaking based on the observation of staining under the tank and adjacent to the tank. This is a double-walled tank owned by Safety-Kleen Corporation. MAX checked the tank, and it is not leaking. We did move the tank aside to clean up any stains from the pavement. NEIC also noted that PADEP regulations require that vessels used for waste oil storage be labeled “waste oil”, not “used oil”. MAX affixed a “Waste Oil” label on the tank (see attached photo).

Waste
Oil
