# VP1373 Max Photos

| Project Number | VP1373 |
| Photographer | L. Goodnight |

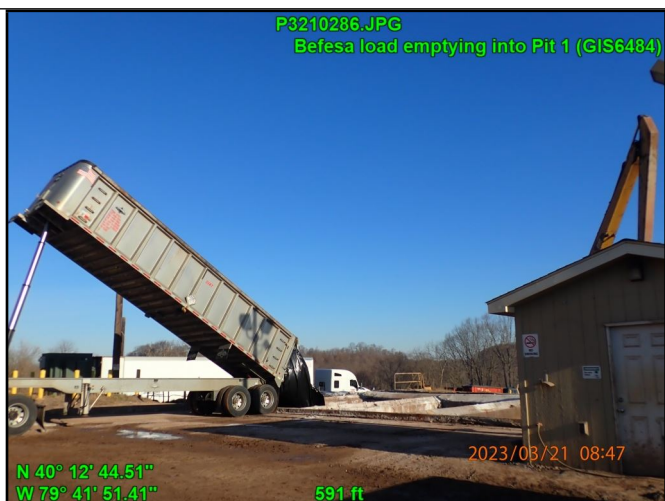
| Photograph Number | 1 |

| Description | Befesa load emptying into Pit 1 (GIS6484) |

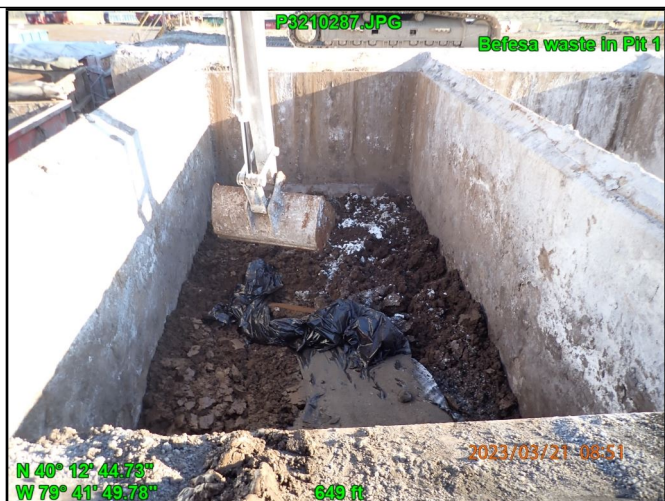
| Photograph Number | 2 |

| Description | Befesa waste in Pit 1 |

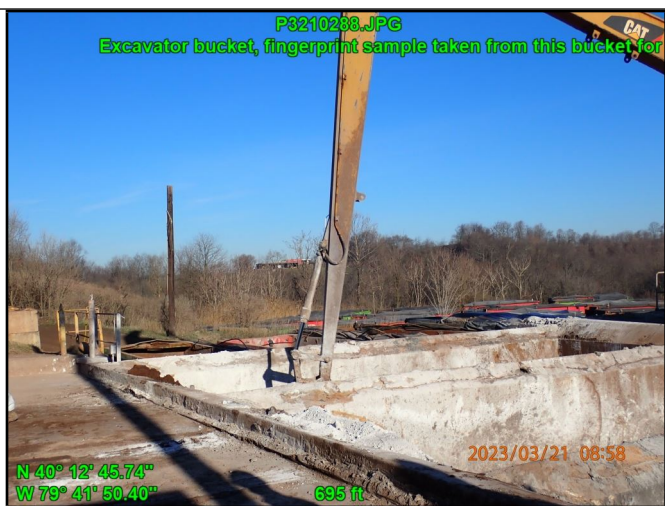
| Photograph Number | 3 |

| Description | Excavator bucket, fingerprint sample taken from this bucket for fingerprinting of first truckload in Pit 1 |

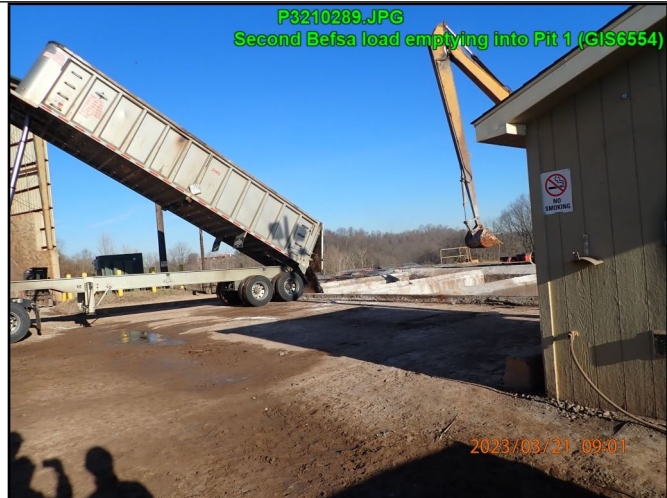
| Photograph Number | 4 |

| Description | Second Befsa load emptying into Pit 1 (GIS6554) |

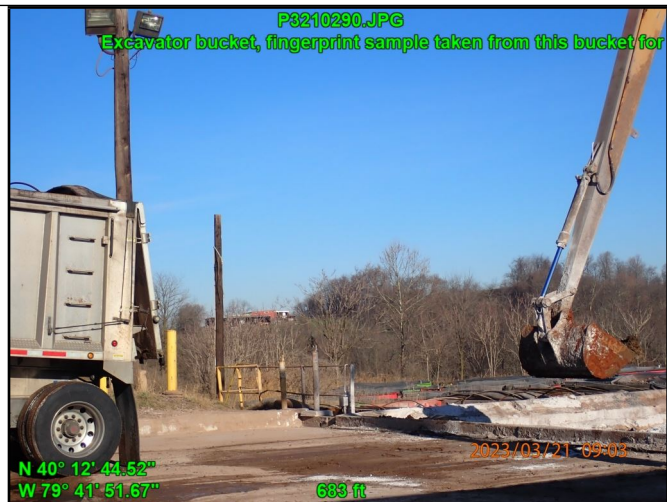
| Photograph Number | 5 |

| Description | Excavator bucket, fingerprint sample taken from this bucket for fingerprinting the second truckload |

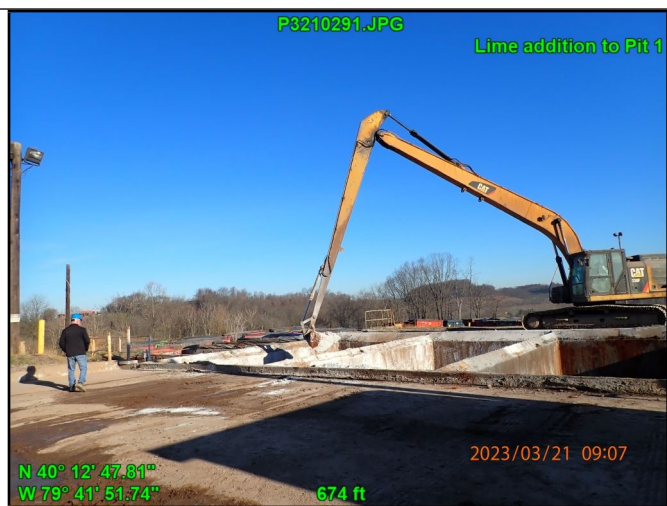
| Photograph Number | 6 |

| Description | Lime addition to Pit 1 |

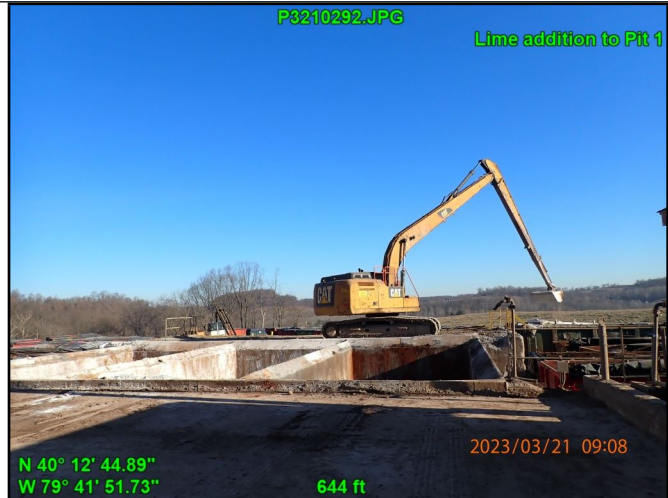
| Photograph Number | 7 |

| Description | Lime addition to Pit 1 |

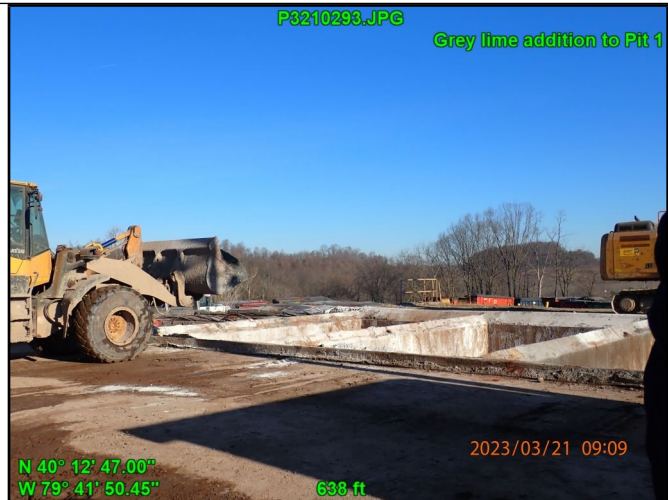
| Photograph Number | 8 |

| Description | Grey lime addition to Pit 1 |

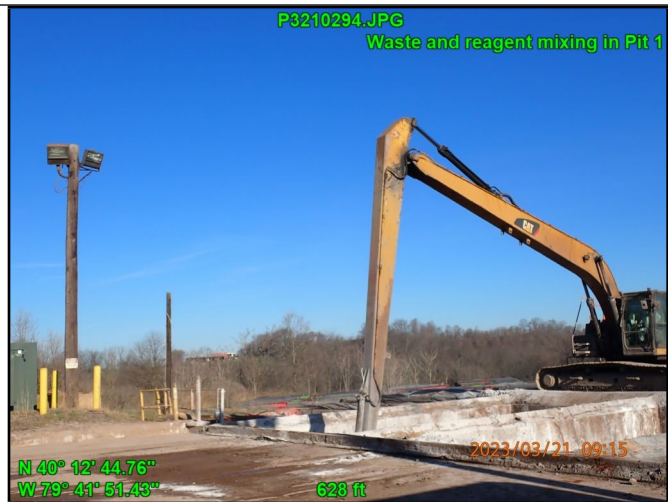
| Photograph Number | 9 |

| Description | Waste and reagent mixing in Pit 1 |

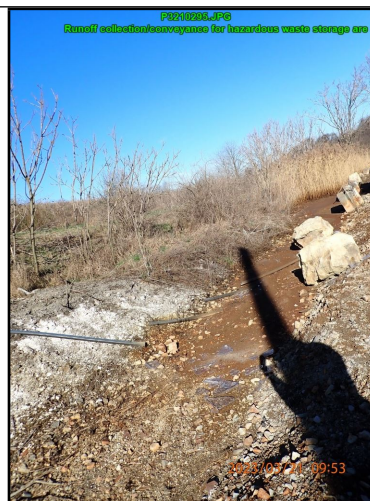
| Photograph Number | 10 |

| Description | Runoff collection/conveyance for hazardous waste storage area 4 |

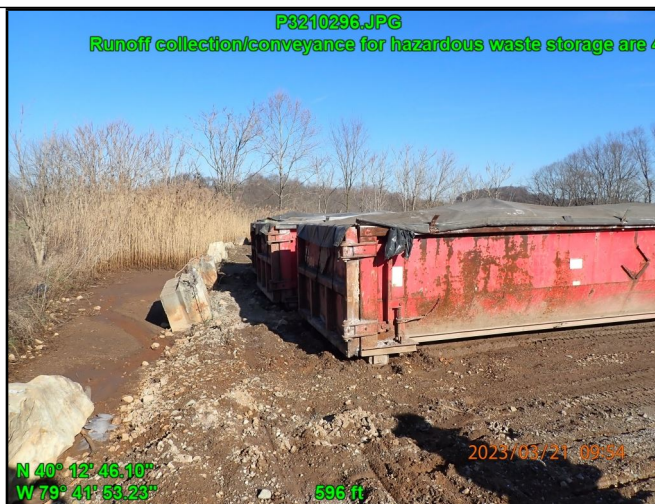
| Photograph Number | 11 |

| Description | Runoff collection/conveyance for hazardous waste storage area 4 |

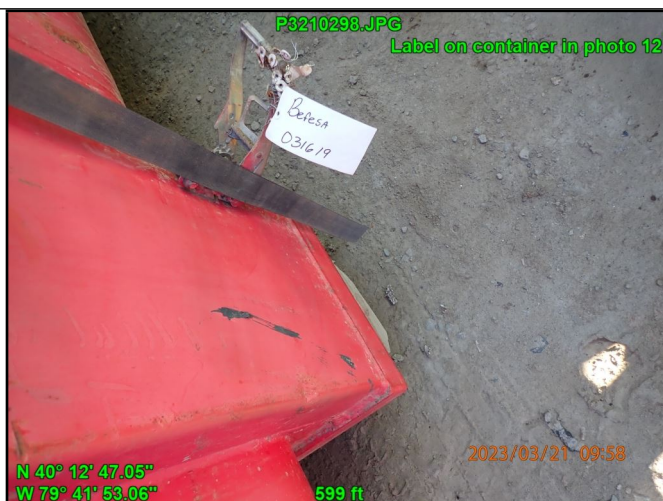
| Photograph Number | 13 |

| Description | Label on container in photo 12 |

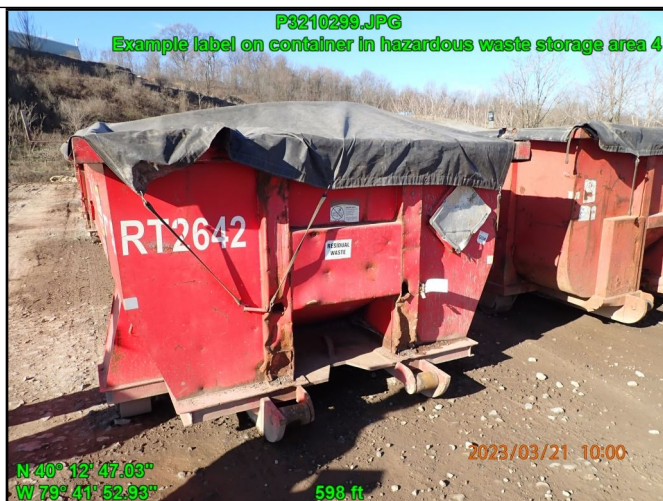
| Photograph Number | 14 |

| Description | Example label on container in hazardous waste storage area 4 |

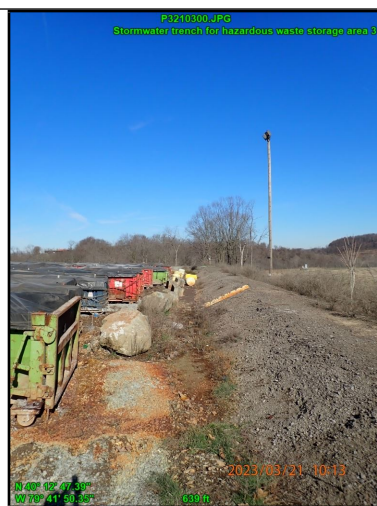
| Photograph Number | 15 |

| Description | Stormwater trench for hazardous waste storage area 3 |

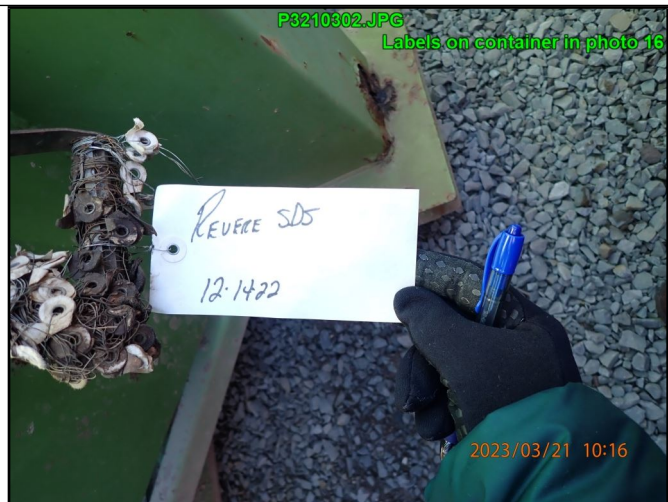
| Photograph Number | 17 |

| Description | Labels on container in photo 16 |

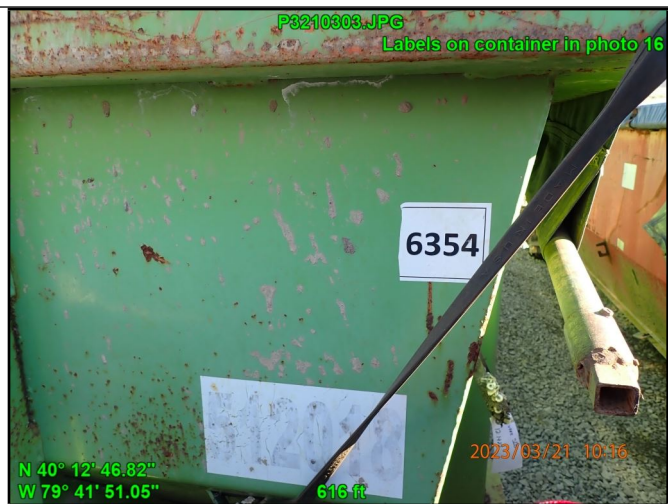
| Photograph Number | 18 |

| Description | Labels on container in photo 16 |

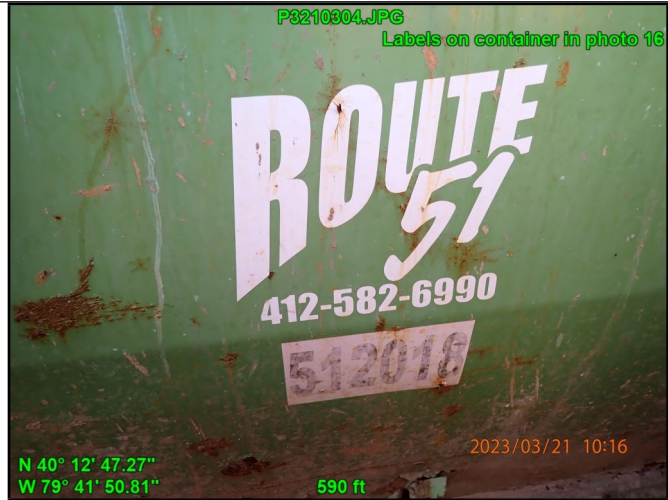
| Photograph Number | 19 |

| Description | Labels on container in photo 16 |

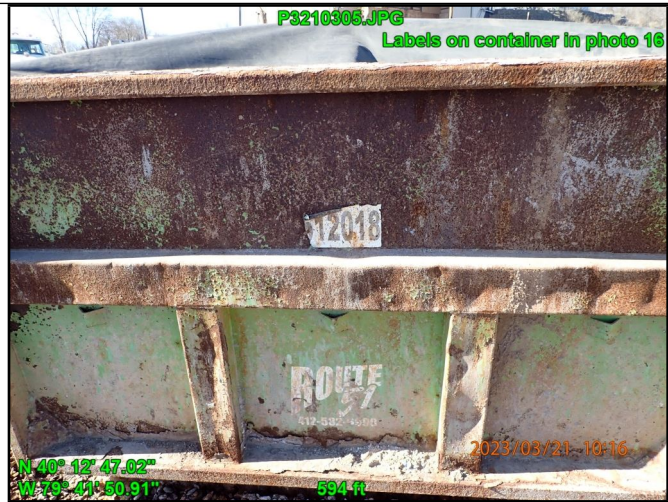
| Photograph Number | 20 |

| Description | Labels on container in photo 16 |

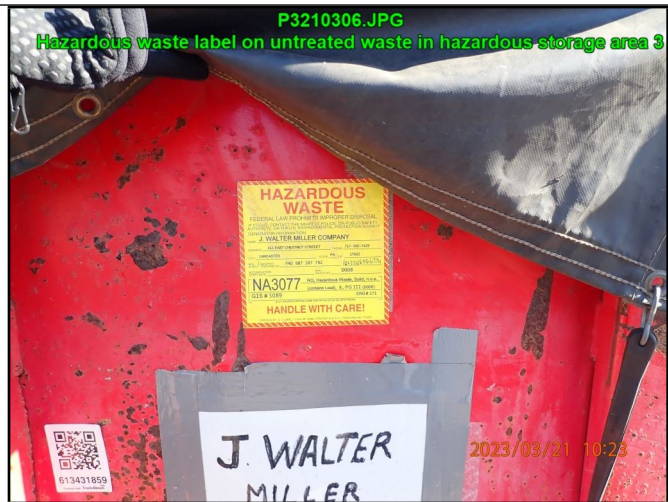
| Photograph Number | 21 |

| Description | Hazardous waste label on untreated waste in hazardous storage area 3 |

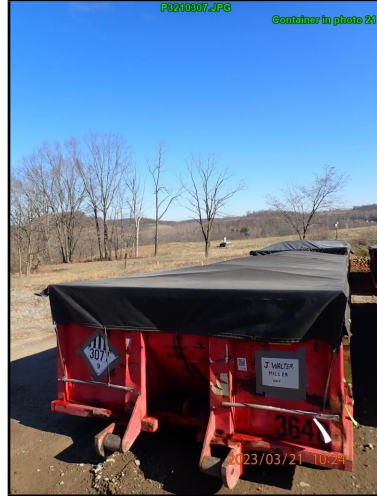
| Photograph Number | 22 |

| Description | Container in photo 21 |

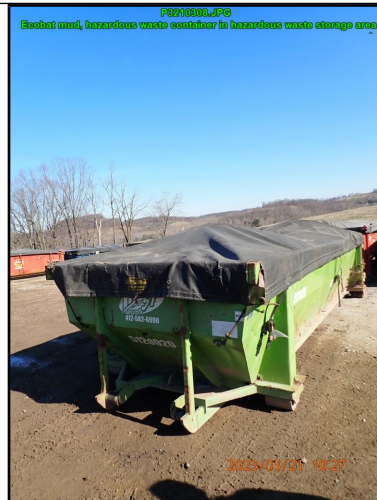
| Photograph Number | 23 |

| Description | Ecobat mud, hazardous waste container in hazardous waste storage area 3 |

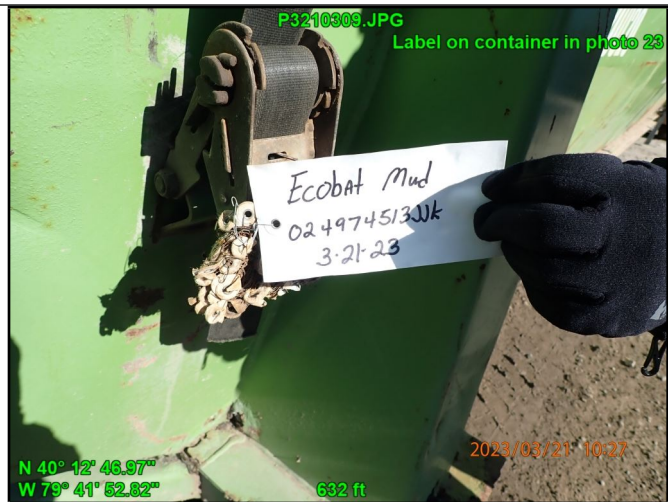
| Photograph Number | 24 |

| Description | Label on container in photo 23 |

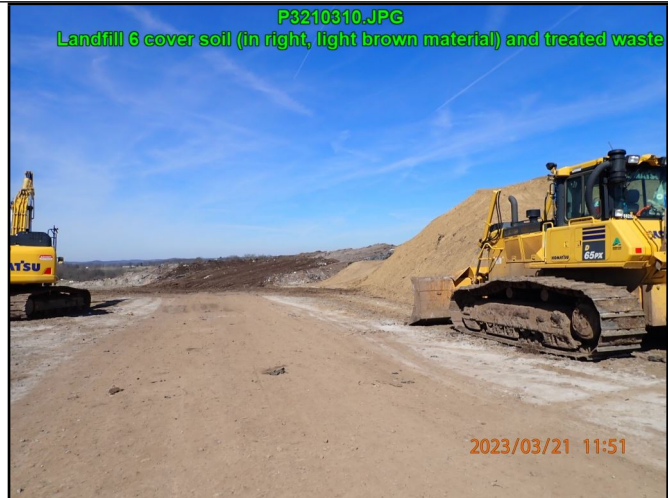
| Photograph Number | 25 |

| Description | Landfill 6 cover soil (in right, light brown material) and treated waste (center of photo, darker brown) |

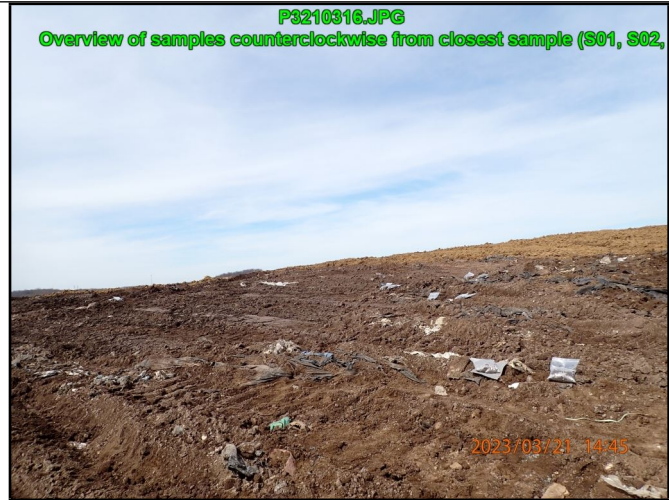
| Photograph Number | 31 |

| Description | Overview of samples counterclockwise from closest sample (S01, S02, S03, S04, S05) |

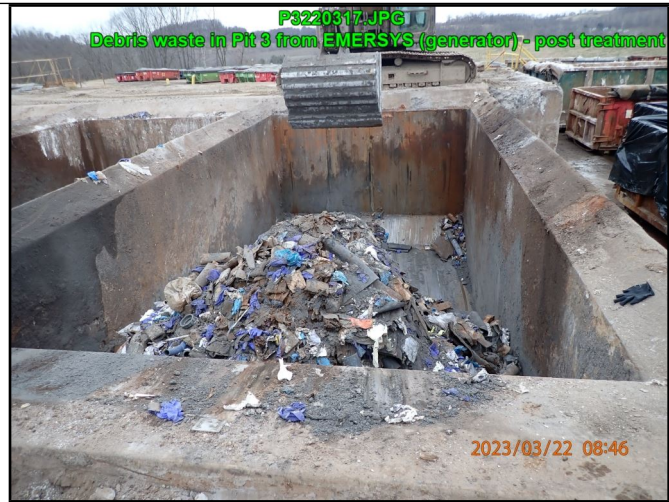
| Photograph Number | 32 |

| Description | Debris waste in Pit 3 from EMERSYS (generator) - post treatment |

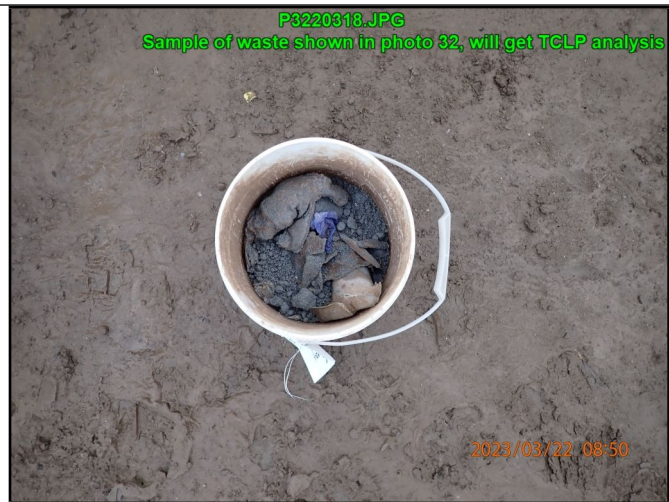
| Photograph Number | 33 |

| Description | Sample of waste shown in photo 32, will get TCLP analysis |

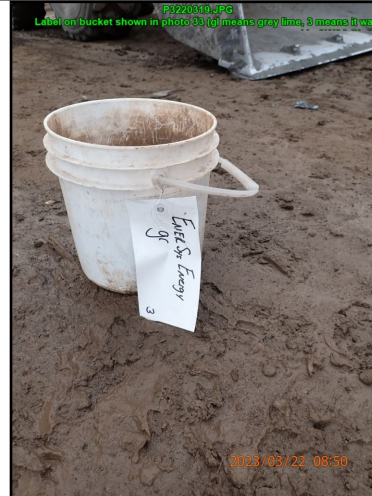
| Photograph Number | 34 |

| Description | Label on bucket shown in photo 33 (gl means grey lime, 3 means it was treated in SWSS Pit 3) |

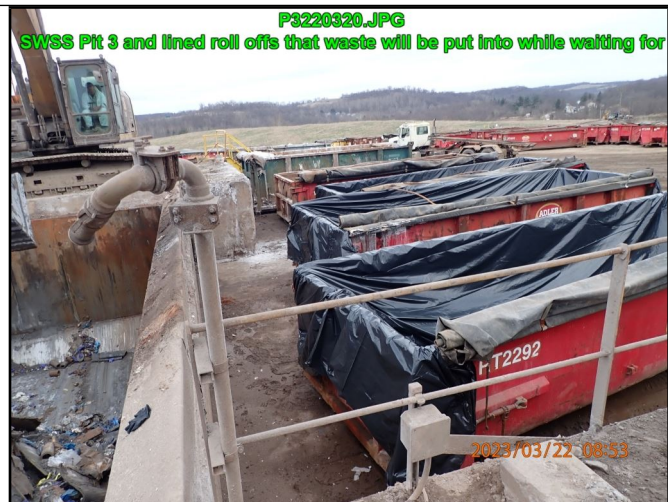
| Photograph Number | 35 |

| Description | SWSS Pit 3 and lined roll offs that waste will be put into while waiting for TCLP results |

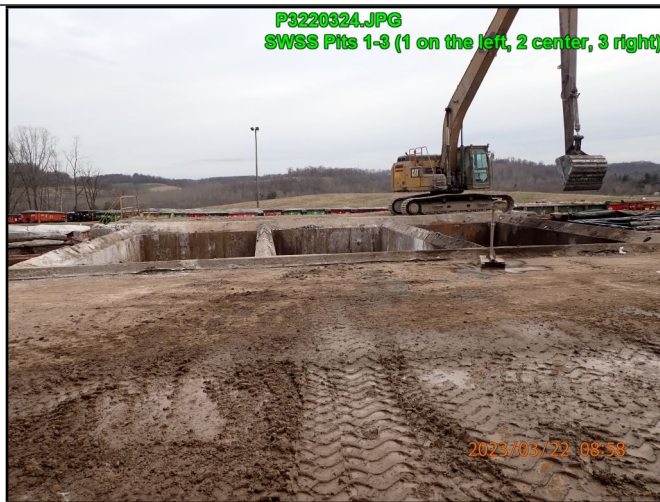
| Photograph Number | 39 |

| Description | SWSS Pits 1-3 (1 on the left, 2 center, 3 right) |

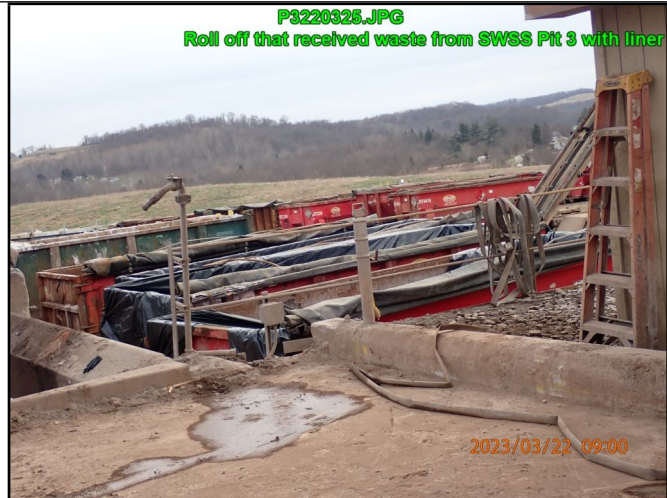
| Photograph Number | 40 |

| Description | Roll off that received waste from SWSS Pit 3 with liner |

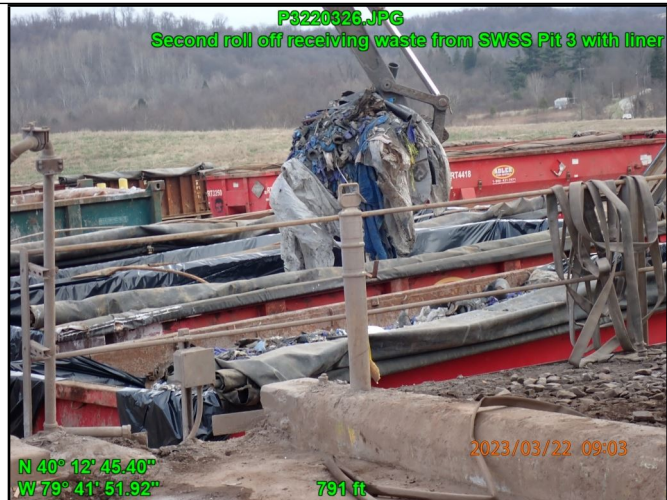
| Photograph Number | 41 |

| Description | Second roll off receiving waste from SWSS Pit 3 with liner |

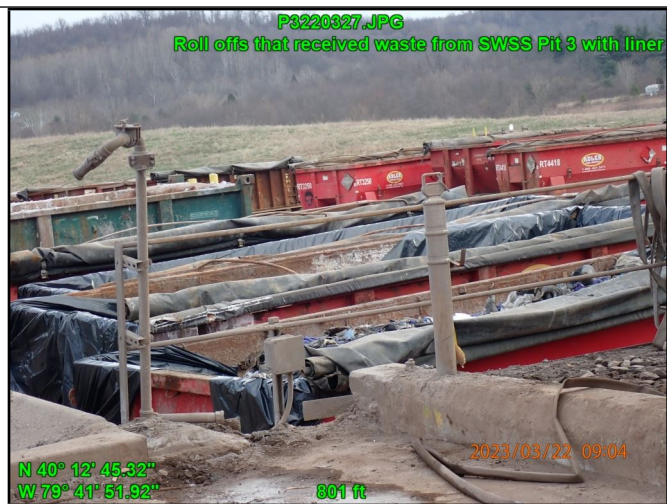
| Photograph Number | 42 |

| Description | Roll offs that received waste from SWSS Pit 3 with liner |

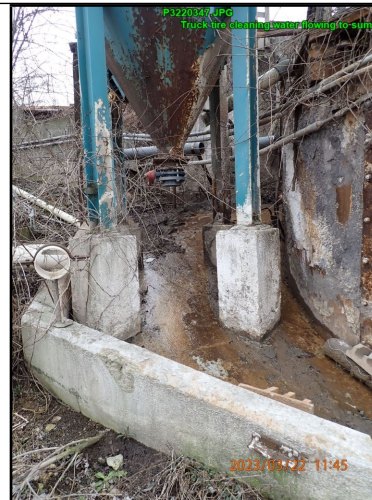
| Photograph Number | 63 |

| Description | Truck tire cleaning water flowing to sump |

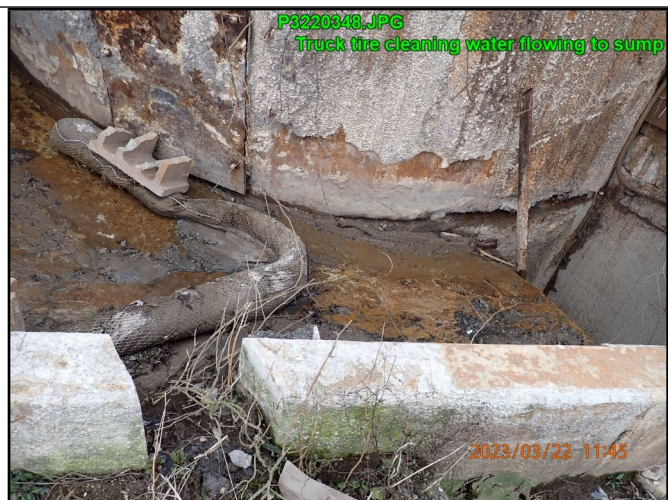
| Photograph Number | 64 |

| Description | Truck tire cleaning water flowing to sump |

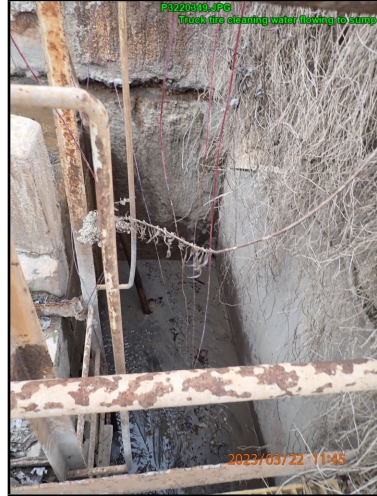
| Photograph Number | 65 |

| Description | Truck tire cleaning water flowing to sump |

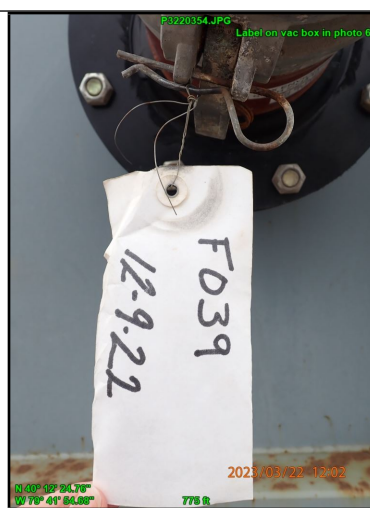
| Attributes | |
|---|---|
| Photograph Number | 70 |

| Attributes | |
|---|---|
| Description | Other side of F039 vac box (same as photos 68 and 69) |

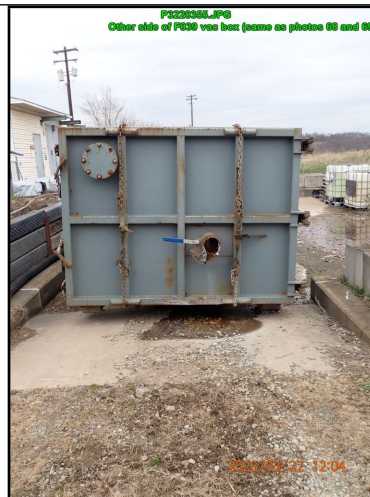
| Attributes | |
|---|---|
| Photograph Number | 71 |

| Attributes | |
|---|---|
| Description | Other side of F039 vac box (same as photos 68 and 69) |

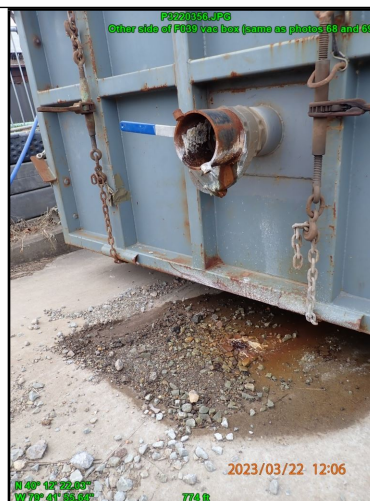
| Attributes | |
|---|---|
| Photograph Number | 72 |

| Attributes | |
|---|---|
| Description | F039 pad |

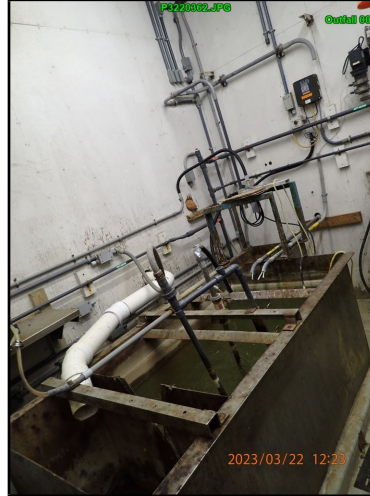
| Photograph Number | 78 |

| Description | Debris being treated in SWSS Pit 3 |

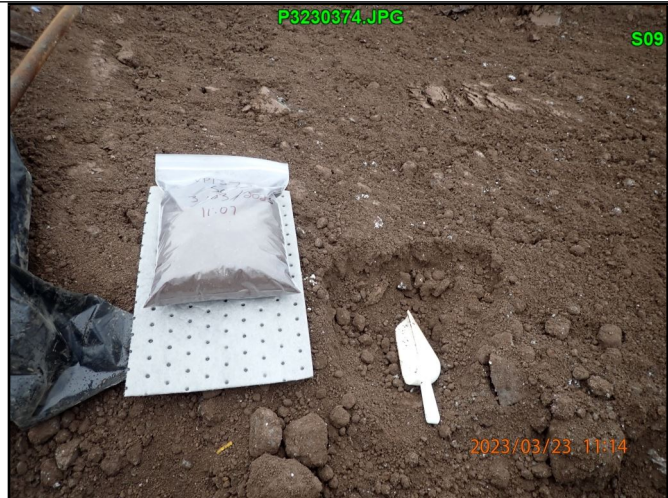
| Description | S09 |

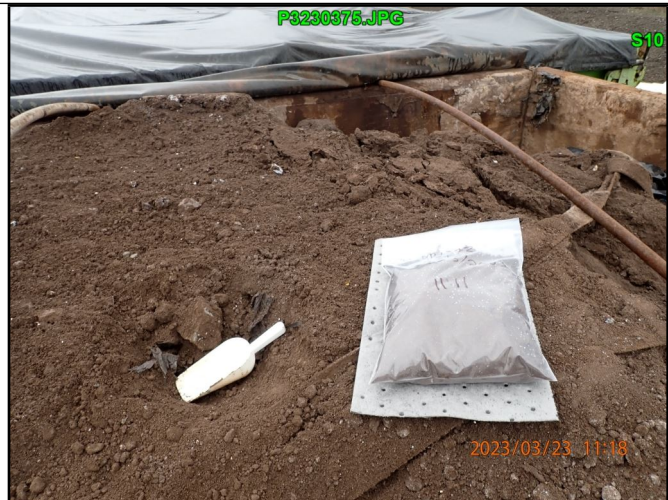
| Photograph Number | 90 |

| Description | S10 |

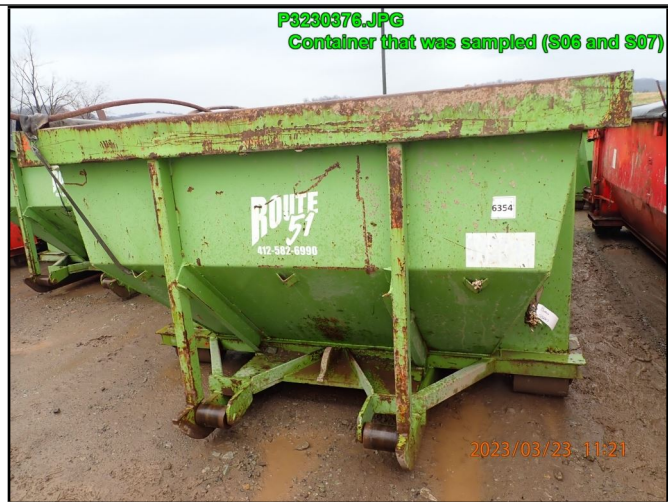
| Photograph Number | 91 |

| Description | Container that was sampled (S06 and S07) |

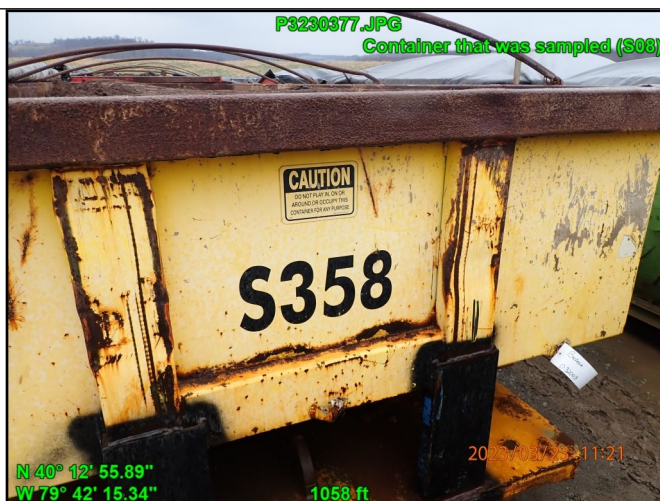
| Photograph Number | 92 |

| Description | Container that was sampled (S08) |

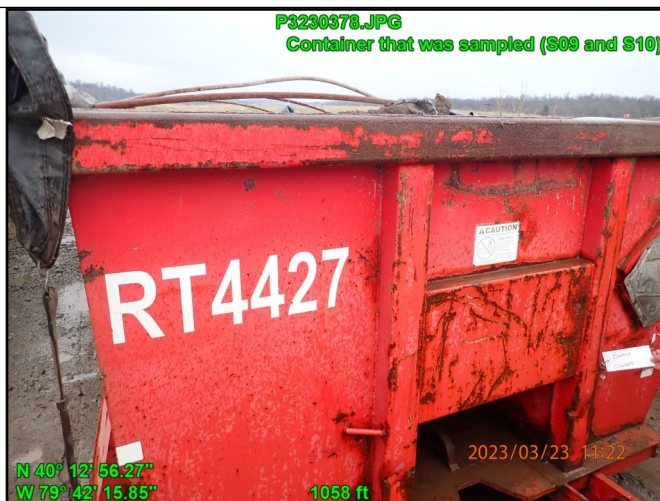
| Photograph Number | 93 |

| Description | Container that was sampled (S09 and S10) |

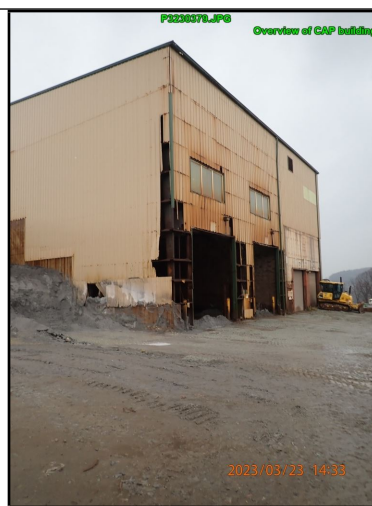
| Photograph Number | 94 |

| Description | Overview of CAP building |

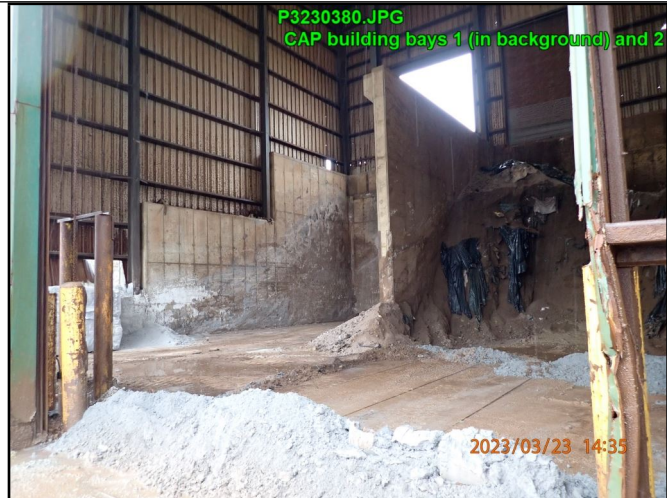
| Photograph Number | 95 |

| Description | CAP building bays 1 (in background) and 2 |

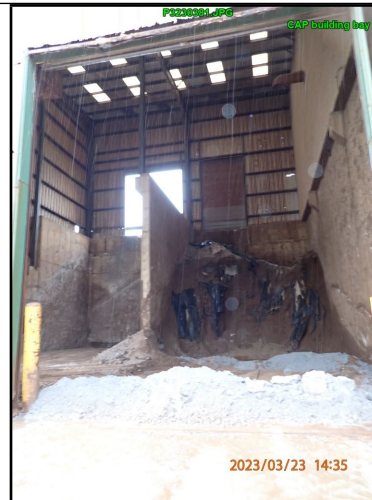
| Photograph Number | 96 |

| Description | CAP building bay 2 |

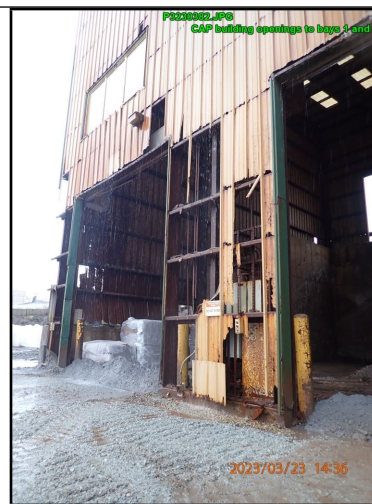
| Photograph Number | 97 |

| Description | CAP building openings to bays 1 and 2 |

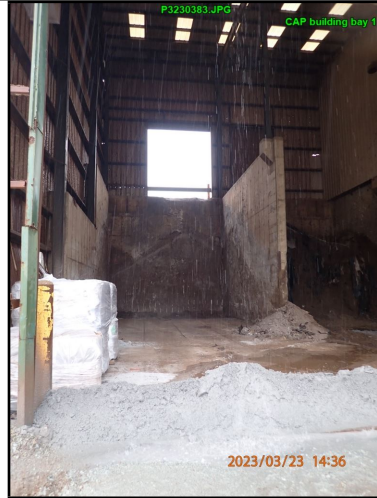
| Photograph Number | 98 |

| Description | CAP building bay 1 |

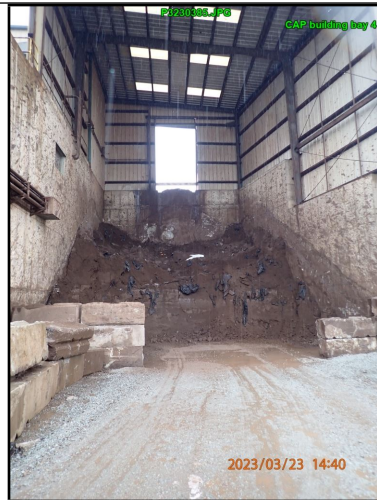
| Photograph Number | 100 |

| Description | CAP building bay 4 |

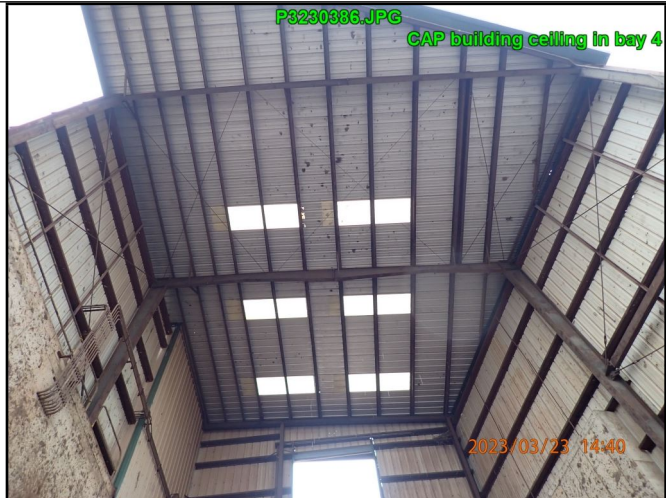
| Attributes | |
|---|---|
| Photograph Number | 101 |

| Attributes | |
|---|---|
| Description | CAP building ceiling in bay 4 |

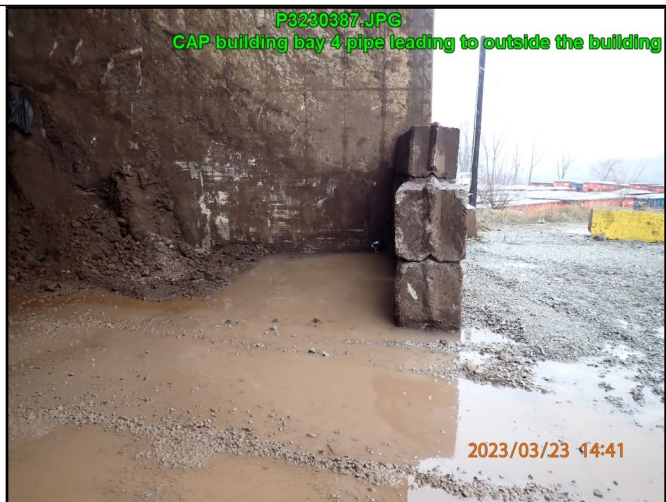
| Attributes | |
|---|---|
| Photograph Number | 102 |

| Attributes | |
|---|---|
| Description | CAP building bay 4 pipe leading to outside the building |
